Need for Airspeed

Pitot clogs and forgotten covers cause their share of smoked tires, runway overruns and outright crashes

By Steven DeGross

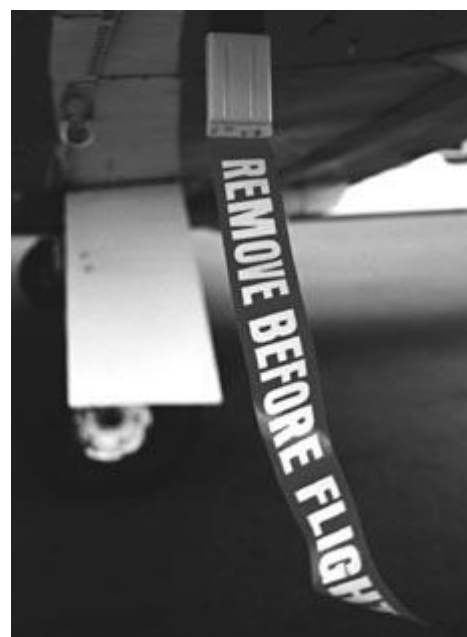
Visible flag, yes, but a distraction could keep you from looking under the wing.

Pitot tubes are typically protected while on the ground by using pitot tube covers of various designs. They include flexible plastic tubes that fit tightly onto the pitot tube or covers that fit loosely over the pitot tube and attach with Velcro or other means. These types of pitot tube covers typically have a “remove before flight” streamer hanging from them as a visual aid in reminding the pilot to remove the pitot cover during preflight.

Unfortunately, as the accident record illustrates, it is not uncommon for a pilot to miss removing the pitot tube cover, or miss examining the opening of the pitot tube for foreign object debris. That failure may be due to distraction or dark night conditions, but what it really boils down to is the fact that many pilots conduct rushed or inadequate preflight inspections.

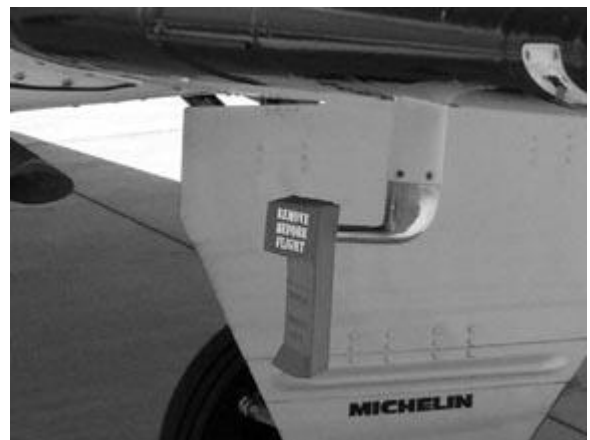
The pitot cover developed by the author falls away as the airplane gathers takeoff speed.

Recently DeGroff Aviation unveiled an improved pitot-tube cover that not only keeps insects and spiders from gaining access to the pitot tube opening, but disengages and falls harmlessly away from the aircraft during the takeoff roll if it's not removed during preflight.

This improved pitot cover significantly reduces the potential for an accident, and therefore will reduce the number of accidents occurring in the most critical phase of flight. The foam cover sticks onto either pointed probes or most of the blade-type pitot tubes and presents a flat face into the wind during the takeoff roll. At about 50 knots, the wind resistance is enough to blow it off. The ethylene vinyl acetate foam won't hurt an airframe or propeller. What it might do to a turbine engine is open to debate, with some manufacturers saying it won't hurt at all and others taking the position that the engine would be inspected as after a bird strike.
