PITOTSHIELDS™
SAFETY PITOT COVERS

PitotShield V2™ Detaining Bridle Instructions

OVERVIEW OF THE PSV2™ DETAINING BRIDLE

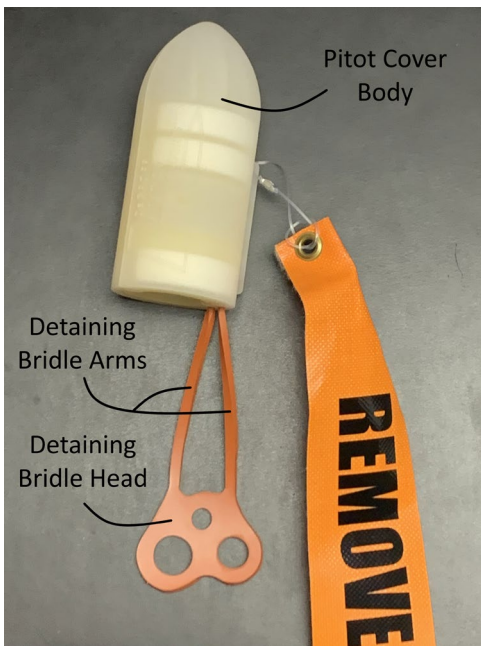
Fig. 1

Figure 1 shows the Detaining Bridle option in place on a PitotShield V2™ Body.

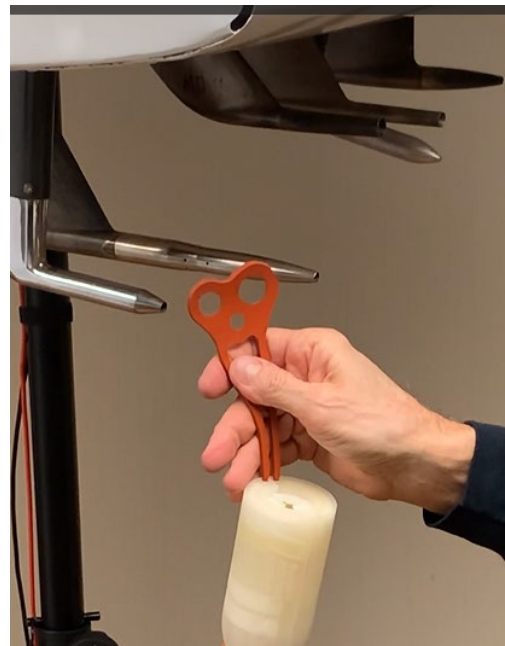
Fig 2

Place the bridle head up to the pitot tube (Fig 2) to determine which hole most closely measures approximately 1/16" to 1/8" smaller than the pitot tube diameter at approximately three inches back from the tip.

Using both hands, grasp the head of the bridle on either side of the appropriate hole, with the PitotShield body oriented as shown in fig 2. Slide the bridle onto the pitot tube (Fig 3) to about 3 ½ inches from the pitot tube tip (fig 4). The bridle should slide onto the pitot tube with slightly firm resistance.

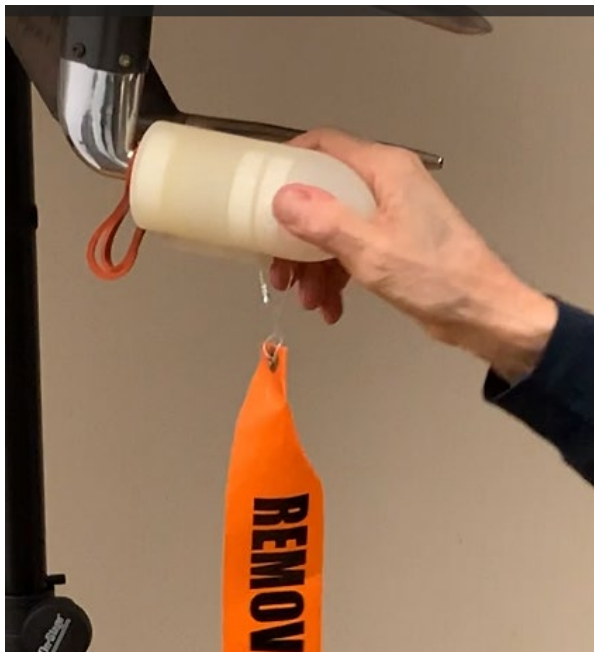
Fig. 5

Grasp the PitotShield with the RBF Streamer oriented down, assuring the Bridle Arms are not crossed, and slide the PitotShield V2™ onto the pitot tube until a hard stop is felt (Fig. 5). Your pitot tube is now protected.

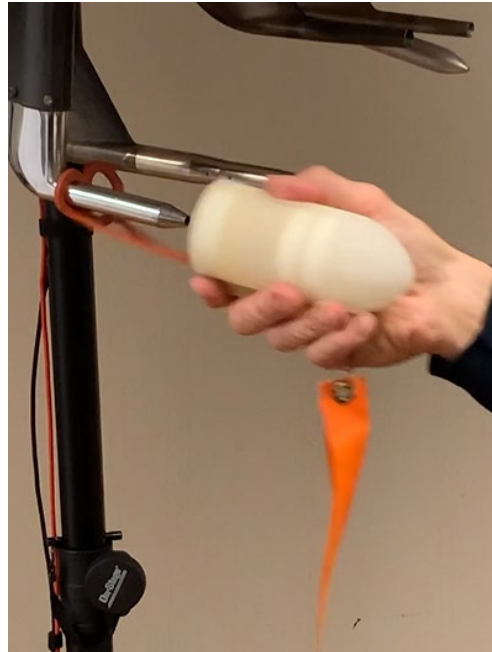
Fig. 6

After confirming the pitot heat is off and the pitot tube is cool, grasp the PitotShield body (Fig 6) and pull straight forward, off the pitot tube just until the back of the cover is clear of the pitot tube tip. Then, allowing the pitot cover body to hang by the Bridle Arms, using two hands (Fig 4), slide the bridle forward and off the pitot tube.

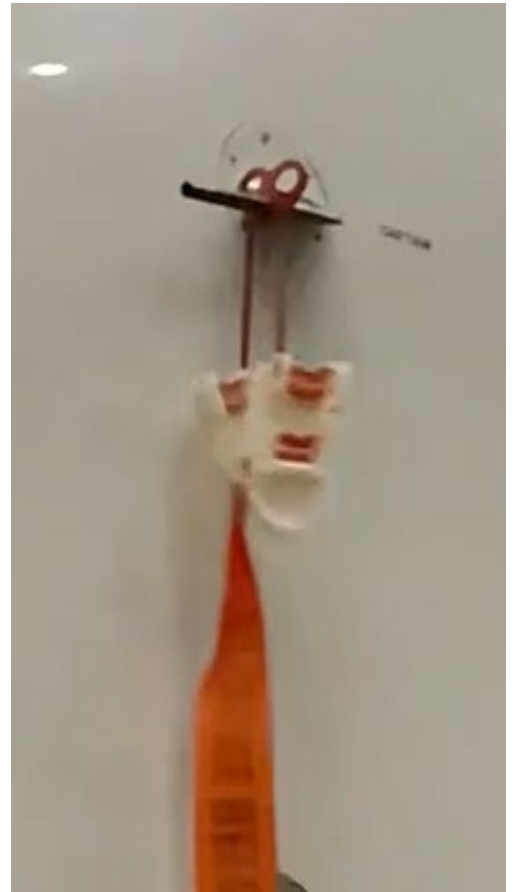
Fig. 7

If the pitot heat has been activated and the PitotShield V2 has deployed and hanging by the Bridle (Fig 7), confirm pitot heat is off and the pitot tube is cool. The Bridle can then be carefully removed using two hands as described above.

Note that some pitot heat systems are such that their pitot tube temperatures are sufficient to degrade the bridle surface contacting the pitot tube. Crystallization or powdering and/or splits may appear on the bridle hole edges, indicating that its tensile strength will be compromised, particularly while the silicone is hot. This indicates a possibility of the bridle tearing at the hole with further use. Thus, after a thermal ejection, inspect the bridle and replace with new (DAT P/N 77-DBU1) if degradation is observed.
